Work Order ID 149109

Item ID: D4634-143 Accept ***N900040100*** Setup Start ***NS1***
Revision ID: Stop ***NS2***
Item Name: Middle, Center Ceiling Replacement Panel Assembly
Start Date: 7/13/2016 Start Qty: 1.00 ***1*** Cust Item ID:
Required Date: 7/19/2016 Req'd Qty: 1.00 ***1*** Customer:
Reference:

WORK ORDER NON-CONFORMANCE / UPDATE

D4634-143 MIDDLE, CENTER CEILING REPLACEMENT PANEL ASSY

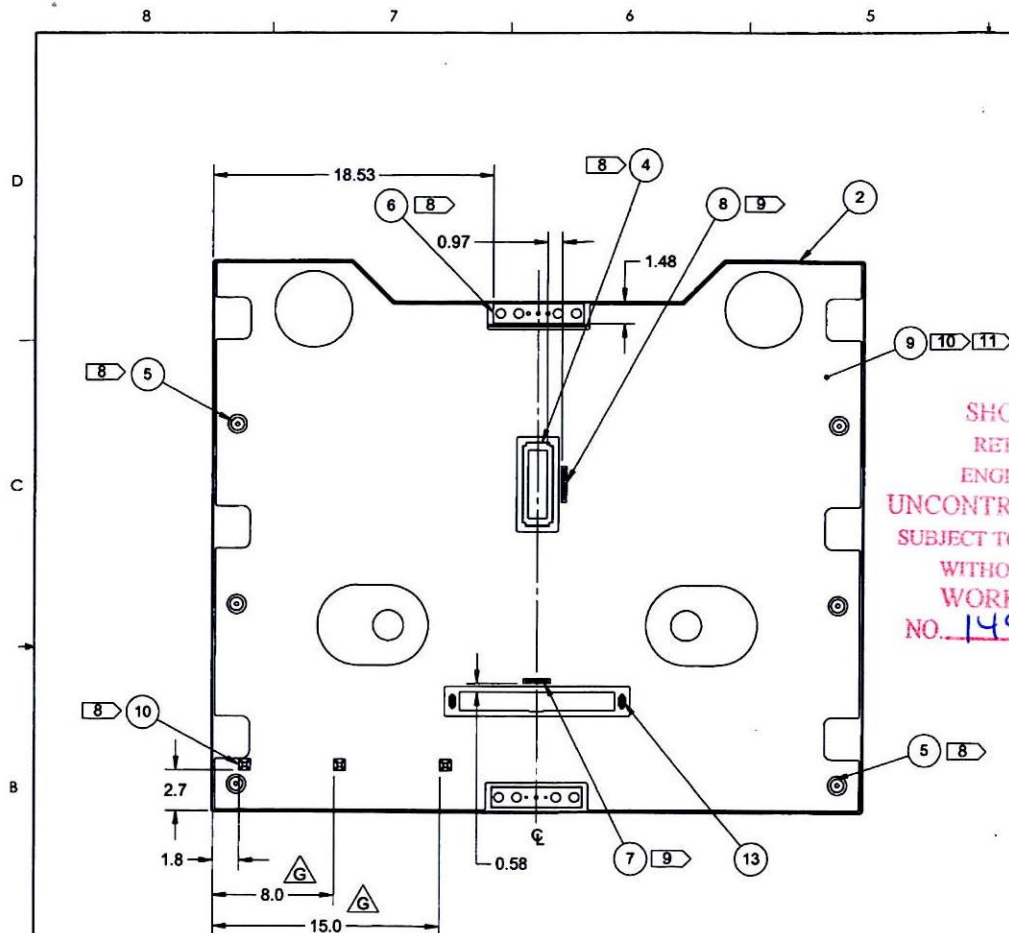
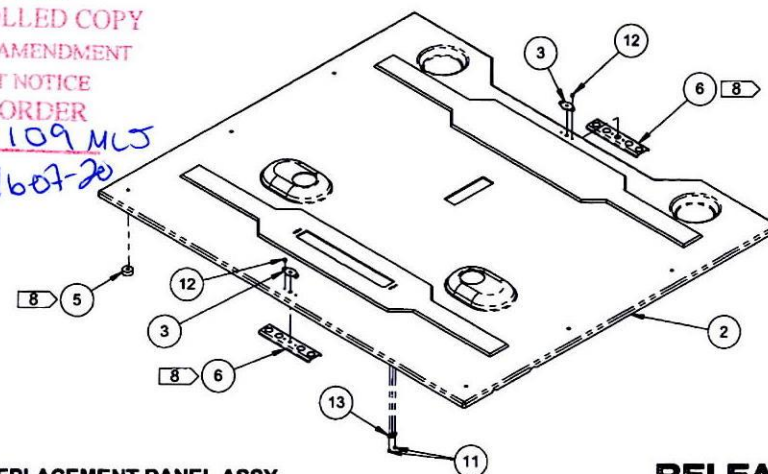
Description Work Order Deviation	Disposition	Completed-By AUG 22 2016 27 9-89
WHILE INSTALLING MS20426AD 3-6 RIVETS THE RIVET WOULD NOT INSTALL WITHOUT DAMAGING LEXAN MATERIAL CAR REQUIRED CAR 46-153	REMOVE MS20426AD 3-6 RIVETS AND INSTALL CCR 264SS-3-03 RIVETS. (QTY 4) M135123	Lead hand / Supervisor Approval Verification DAS 9 9-89 160822
		QC / QA Coordinator Approval DAS 9 9-89 160822
